Manhole Inspection Summary

Manhole # S19MM_020MH

Location Address: **2143 WINDSOR AVE**

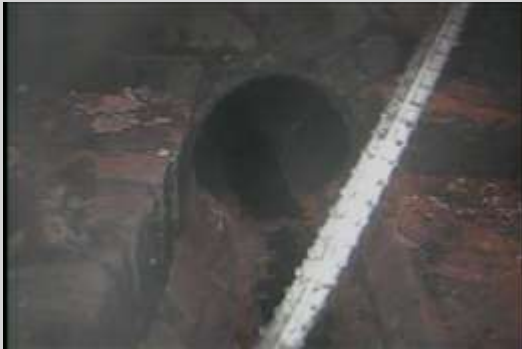
12 O'Clock Outflow

8 in. Circular Gravity Sewer
Pipe Out @ 12 O'Clock

Invert Depth: **11.91** (ft.) Flow Characteristics: **Slow**

Infiltration: **None** Pipe Seal Cond: **Sound**

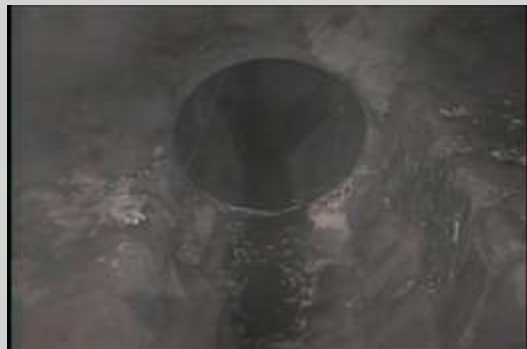
6 O'Clock Inflow

8 in. Circular Gravity Sewer

Pipe In @ 6 O'Clock

Infiltration: **None** Pipe Seal Cond: **Sound**
